NISSENS' TECHNICAL TIPS AC Compressors

NISSENS NUMBER **89036**

MANUFACTURER VOLKSWAGEN
MODEL SERIES TRANSPORTER
MODEL T5 MODELS
YEAR 2003-

PRODUCT SUBJECT CLUTCH PROBLEMS

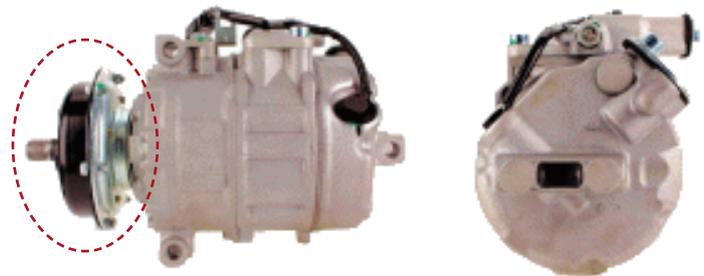
The VW Transporter (T5 model) does not have a conventional clutch that is driven by the belt. This clutch is designed to be pulled by a shaft that is connected to the alternator as well. Therefore an overrunning alternator pulley is mounted at the end of the clutch.

Clutch where the overrunning alternator pulley is mounted:

Once the compressor clutch breaks down, the overrunning alternator pulley has to be replaced. Usually the grease inside the bearing of the pulley escapes, and the pulley starts to drift causing the clutch to fail and the compressor to break down.

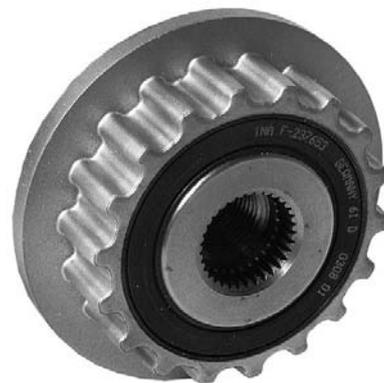
Overrunning alternator pulley:
