Damage to the secondary air pump

Formation of ice and corrosion in the secondary air injection system are the most common causes for secondary air injection pump malfunctions

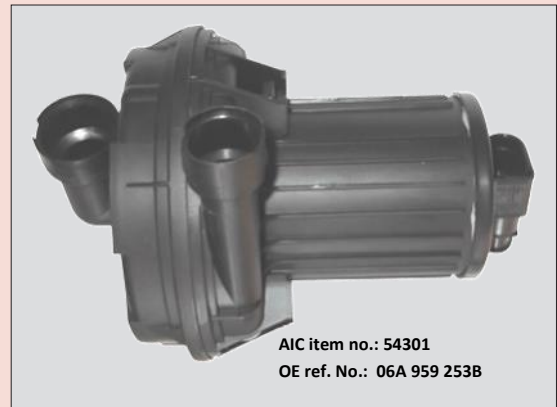
Condensation forms in the secondary air injection pump due to the large temperature differences that exist. In winter, this may freeze causing the pump to be blocked. The electrical part of the pump is also affected by corrosion.

IDENTIFIED DAMAGE

First this will lead to bearing damage and a resulting whistling noise following a cold start. After a certain period of time, the pump malfunctions entirely.

- Besides the exchange of the secondary air injection pump, the automatic recirculation valve (ARV) and the electric switching valve (ESV) should also be thoroughly tested for proper operation and possible leaks.
- The ESV must be checked for electrical activation. If connected incorrectly due to confusing the cables, the recirculation valve can then open at times when it should be shut.
